NEWSLETTER

JUNE 2021

We are reaching out to you about the Mount Nansen Remediation Project. Here is a newsletter to start our conversation again, and to answer some of your questions and concerns about the project.

PROJECT OVERVIEW

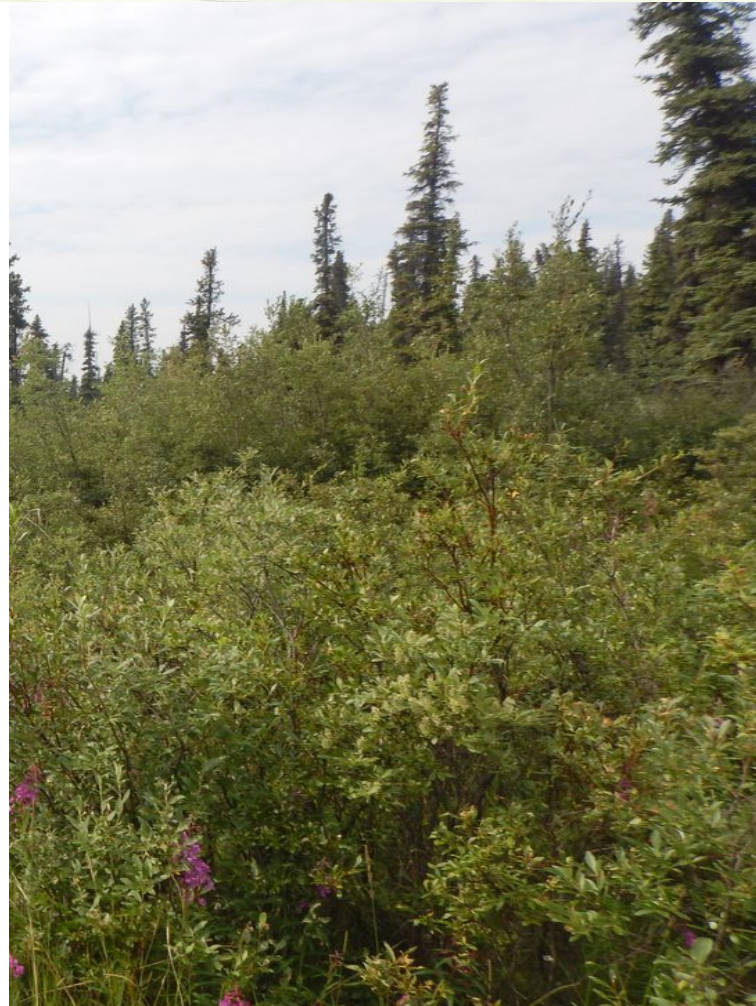
TRENCHES

We have heard that you are concerned about remediating only trenches that have wildlife and erosional issues. We are now proposing to remediate all trenches identified in the original 30% remediation design. These trenches were chosen based on how important they are to wildlife, if they have erosion problems, and how long it will take to naturally revegetate.

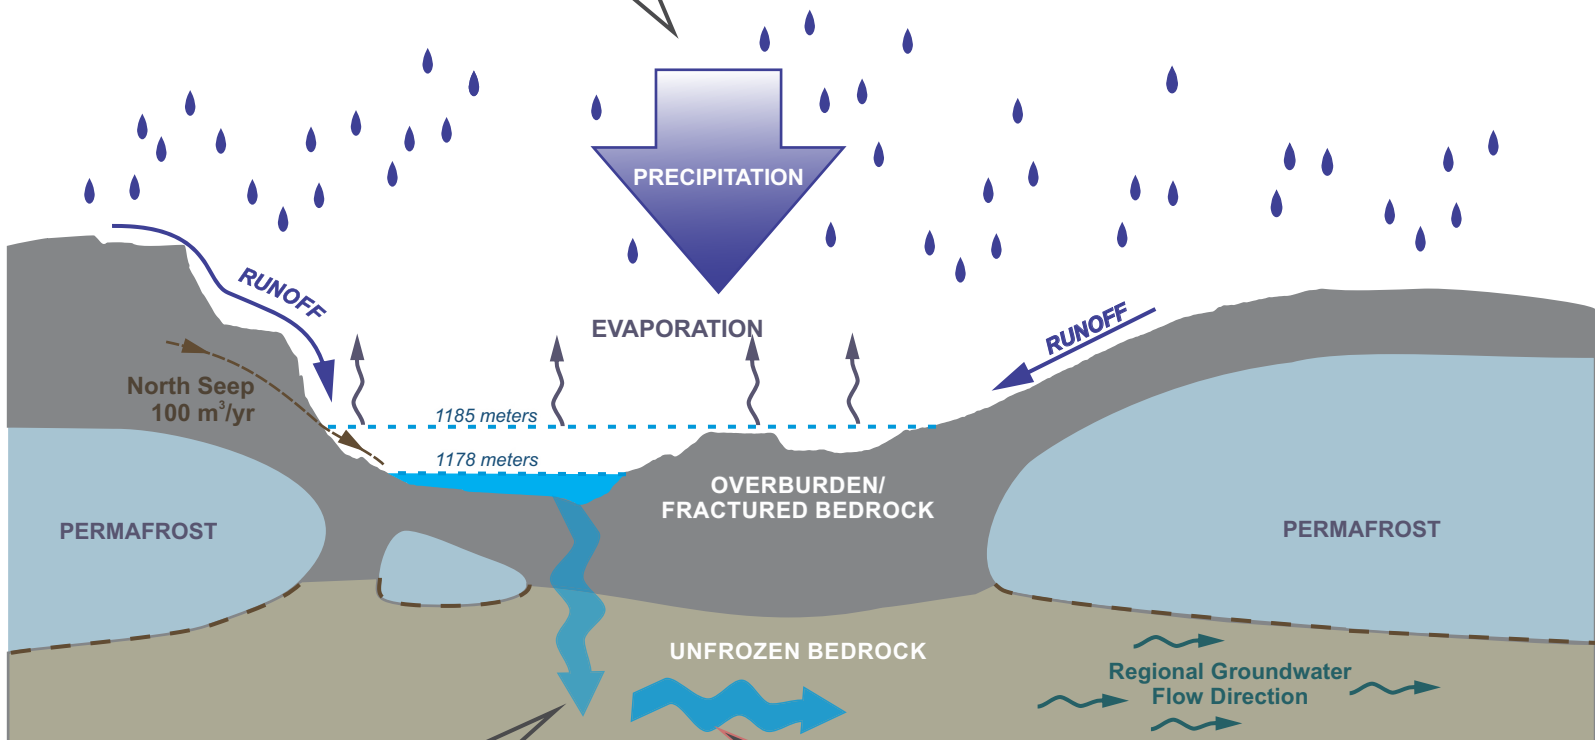
THE PIT - CURRENT CONDITIONS

Currently, the main source of water into the pit is precipitation directly falling within the pit footprint. There are tiny seeps documented in the pit walls, but they produce very little water into the pit. The North Seep has an estimated flow of $100\text{m}^3/\text{yr}$

The pond water level is seasonal, with the highest levels tending to occur in Fall. The Pond Level is Sensitive to the amount of precipitation

Pond Recharge to Groundwater $12,000\text{m}^3/\text{yr}$

Migration of Potentially affected water to Dome Creek $12,000\text{m}^3/\text{yr}$

From 2010-2015, Pond Level fluctuated between 1181.7 to 1184.5 metres amsl. Since 2016, pond level has been below 1180 metres amsl

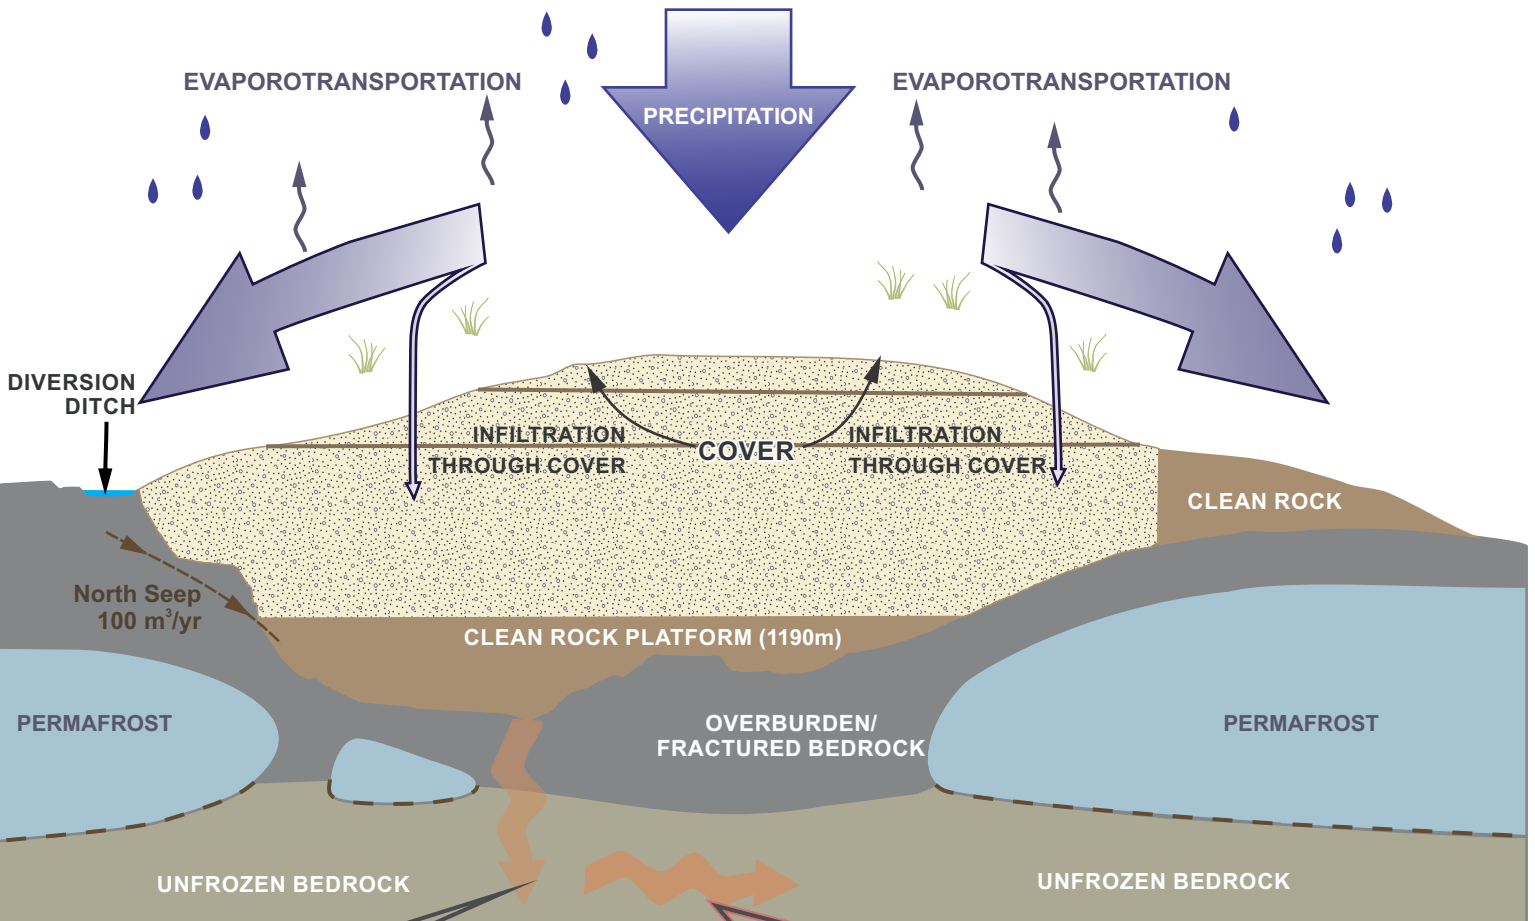
THE PIT - AFTER CLOSURE

The cover and the ditches will greatly reduce the amount of water that will get into the backfill

A cover will be placed over the pit, like an umbrella, to shed water away from the pit.

Water that falls outside of the cover that could flow towards the pit will be captured by ditches and carried away from the pit.

We've considered climate change and seasonal variation in our design.

Backfill Recharge to Groundwater 250 m³/yr

Migration of Potentially affected to Dome Creek 250 m³/year. Seepage from the PCS is 250 m³/year which equals 0.05% of the average yearly flow in Dome Creek

A very small amount of water is expected to flow from the pit backfill into groundwater and then migrate into Dome Creek. Water Quality in Dome Creek will not be significantly altered by this flow. This is one of the reasons why a liner isn't included in the pit design.

Clean Rock Platform is at least 5m higher than the maximum observed pond water level

We have heard that there are concerns about the potential settlement of the cover. We have completed additional modelling on the settlement of the material planned to be in the Pit Containment Structure and carried out additional research on geosynthetic liner strength. The additional modelling and liner research results show us that the cover can be designed to be effective over the long term. We will provide additional cover design details during the Detailed Design phase.
